Manhole Inspection Summary

Manhole # S49U1_002MH

Insp Date: **6/4/08 11:18 AM**

Location Address: **3100 Frankfurst Ave.**

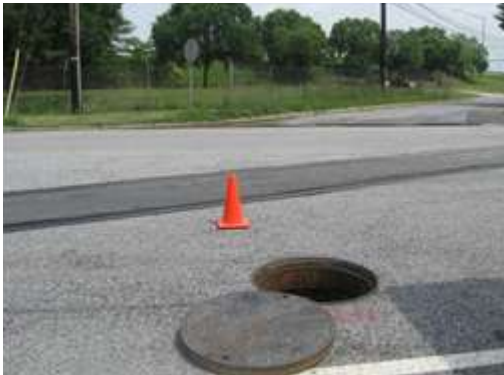
Location View

3100 Frankfurst Ave.

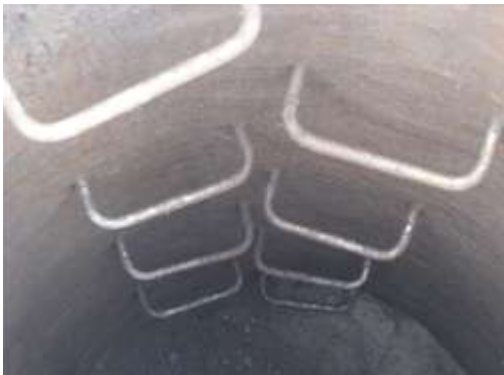
Steps

Count: **8** Missing: **0** ☐ Corroded

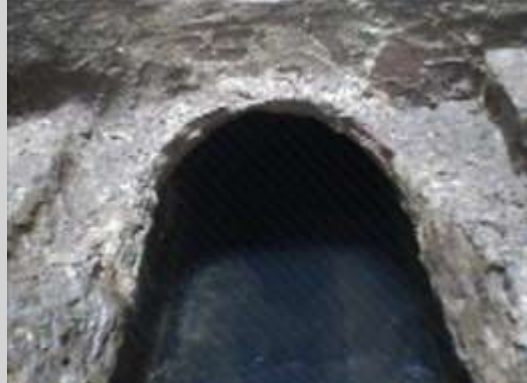
12 O'Clock Outflow

12 in. Circular Gravity Sewer
Pipe Out @ 12 O'Clock

Pipe Height: **12** (in.) Rod and Bar (Angled)
Pipe Material: **Clay** ☐ Pipe Lined
Invert Depth: **13.16** (ft.) Flow Characteristics: **Slow**
Deposits: ☒ None ☐ **Mud** ☐ Sludge ☐ Debris ☐ Grease
Silt Depth: (in.) Deposits Extent:
Infiltration: **None** Pipe Seal Cond: **Sound**

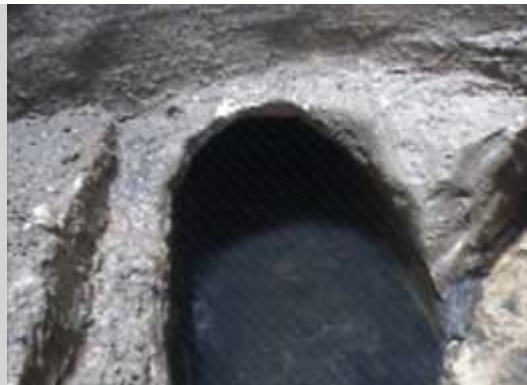
6 O'Clock Inflow

12 in. Circular Gravity Sewer
Pipe In @ 6 O'Clock

Pipe Height: **12** (in.) Rod and Bar (Angled)
Pipe Material: **Clay** ☐ Pipe Lined
Invert Depth: **13.06** (ft.) Flow Characteristics: **Slow**
Deposits: ☒ None ☐ **Mud** ☐ Sludge ☐ Debris ☐ Grease
Silt Depth: (in.) Deposits Extent:
Infiltration: **None** Pipe Seal Cond: **Sound**
